SAVING EEMIL - CONSERVATION PROJECT 2017–2018  
Final report 31.8.2018

The Halonen Museum Foundation – The Art Museum Eemil, Lapinlahti 2018

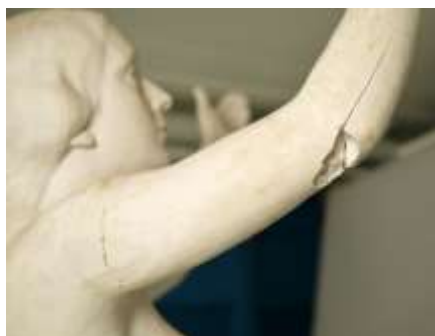
From the conservation point of view, the inherent vulnerability of material is the most characteristic of plaster sculptures. A large number of damages are due to the fragility of the plaster, such as broken pieces, missing parts, holes, marks etc. (*Photos 2 and 3.*)

*Photo 2. Kirkkauteen sculpture with fragmentation and lost areas.*

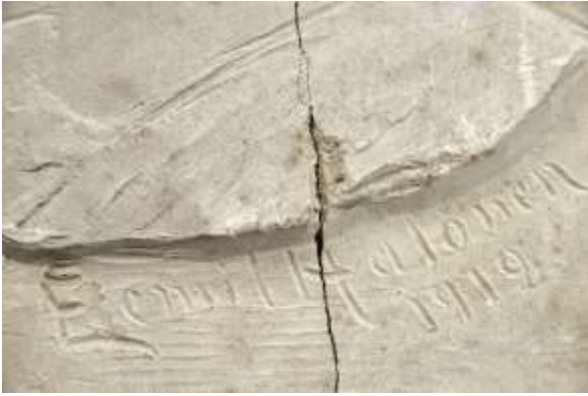
*Photo 3. Plaster relief Kärkkäinen with a crossing fracture and lost edges.*

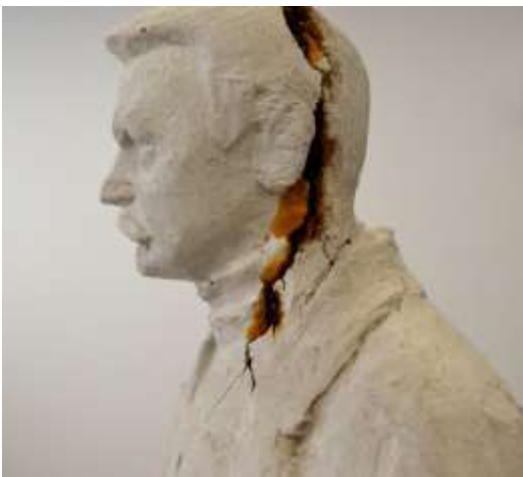
In the past, the sculptors worked out solutions to prevent the vulnerability and fragility of plaster by building metallic structures inside the sculptures. Now, there are many alterations in these structures. The natural oxidation and corrosion of the structures affect the structural stability of many plaster sculptures, and provoke other alterations, such as fractures, broken parts, fragmentation, deformation, exfoliation and disintegration of the surface. (*Photos 4 and 5.*)

*Photo 4. Small figure Edelfelt with broken parts due to oxidation of iron structure.*

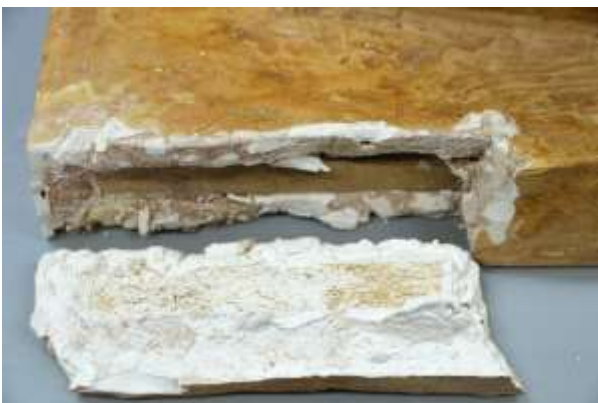
*Photo 5. Aamuhartaus sculpture, one side of the base detached due to wood structure deterioration.*

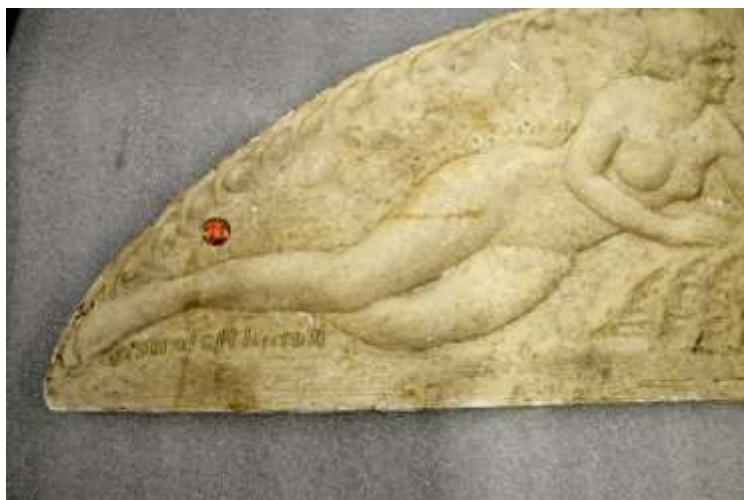
The high rates of humidity and low ventilation in the old storage have caused the evolution of biological growth in many of the plaster objects, probably aggravated by the presence of organic deposits from older coatings, used as release agents or final protective coatings. The dark spots produced by this biological colonisation are shown as chromatic alterations on white plaster and are difficult to remove. (*Photo 6.*)

*Photo 6. Aatami ja Eeva relief with dark spots from biological degradation.*

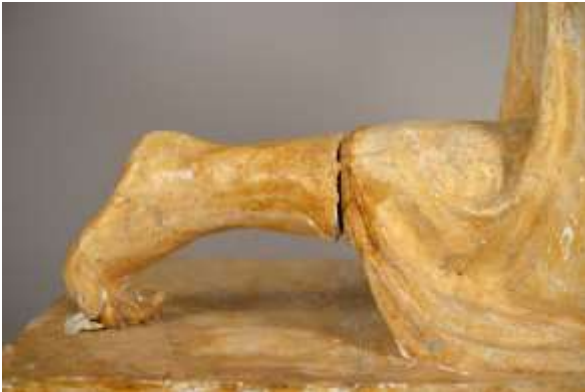
*Photo 7. Mieteissä sculpture with the leg divided for older casting process.*

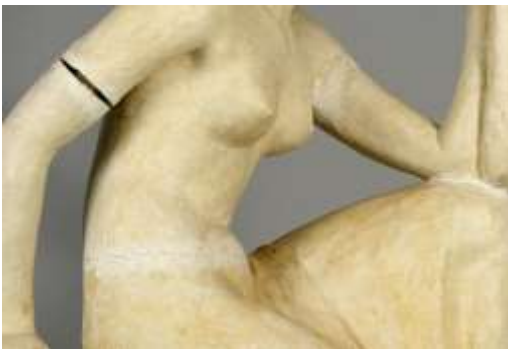
*Photo 8. Elämänlankavyvyhti sculpture with divided parts on the arms and waist.*

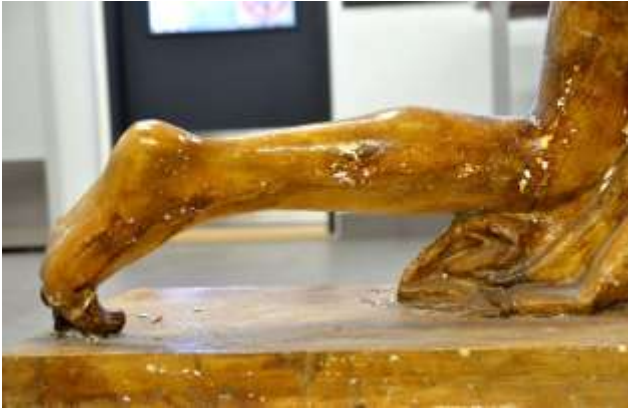
We found a difference between the superficial alterations on plaster sculptures with protective colour coatings and those without. The surface on the sculptures with a protective colour coating were in better condition. These waterproof coatings protect the surface of plaster, preventing access of moisture and dirt deposits, as well as prevention of erosion and marks that show up on the surface of non-coated works of art. However, the condition of these patinas varies greatly. The most visible deterioration that manifests in these kinds of patinas is the loss of adhesion and its cracking. In the most severe cases, the coating rises completely and is lost. (*Photo 9.*)

*Photo 9. Detachment of colour coating on Lyyran soittaja sculpture.*

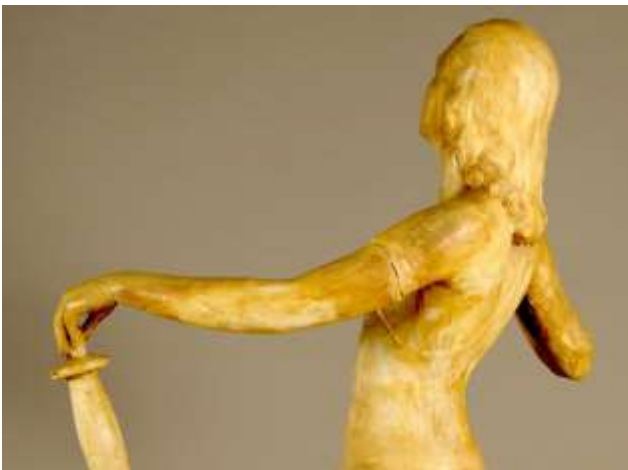
*Photo 10. Chromatic alterations due to old repairs with colour varnish on Kohtalon lanka sculpture.*

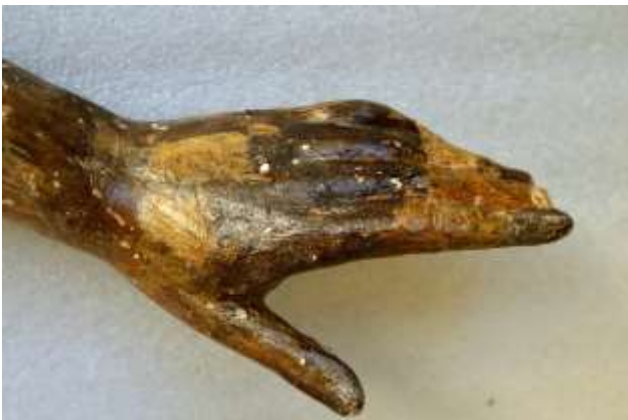
*Photo 11. Chromatic alterations and plaster repairs on the hand of Semper Excelsior Sculpture.*

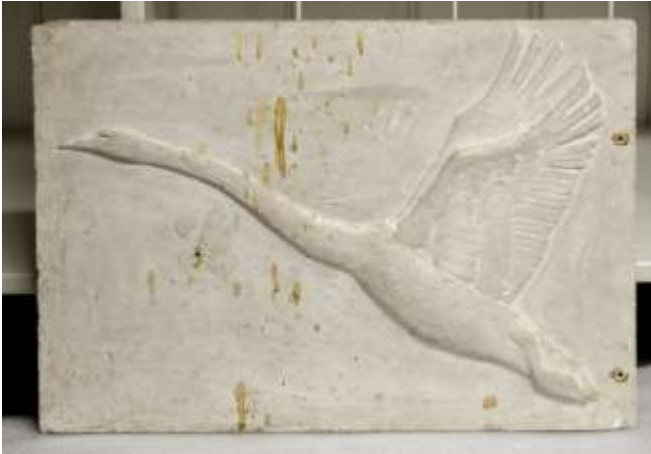
*Photo 12. Dirt residues on the white plaster relief Joutsen.*

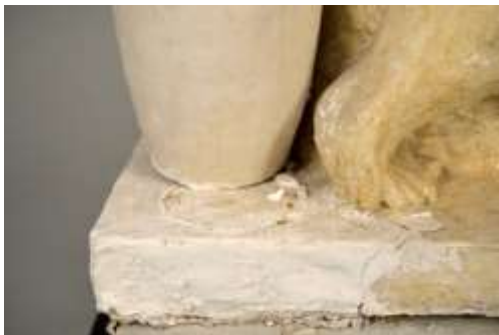
*Photo 13. Old unsuitable reconstruction with plaster on the base of Elämänlankavyöhti sculpture.*

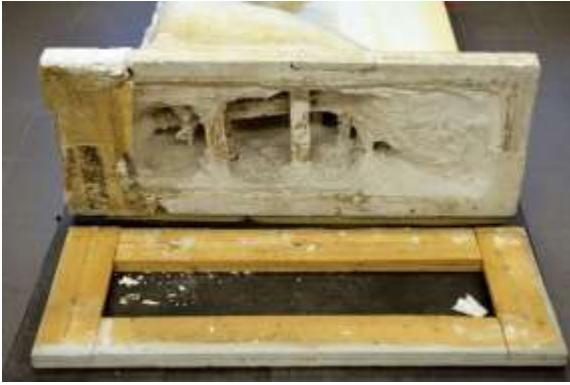
Photo 29. Initial condition on the base of *Elämänlankavyty* sculpture with lost parts, fractures and plaster areas added improperly in old repairs. (Note: newspaper used on plaster repairs.)

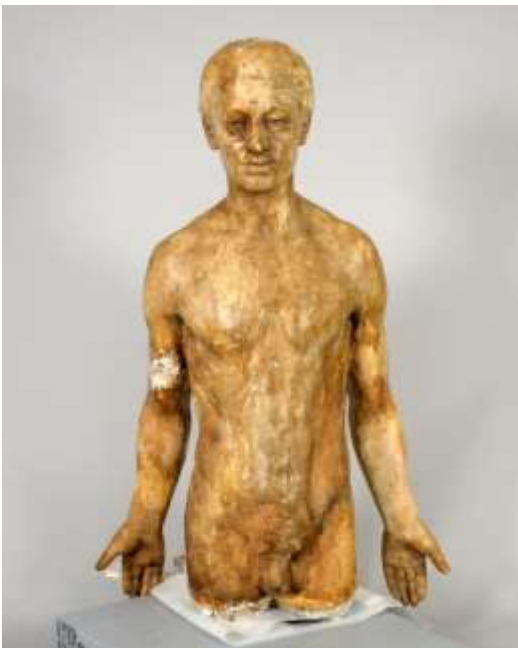
The sculpture had been divided into two parts. Its physical appearance was very much deteriorated due to the poor conservation condition. There were large number of previous repairs and arrangements throughout the entire sculpture. (Photos 37, 38.)

Photo 37. Initial condition of the upper part of the sculpture.

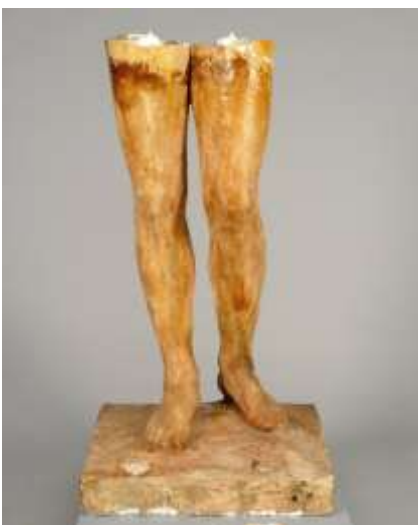
Photo 38. Initial condition of the legs.

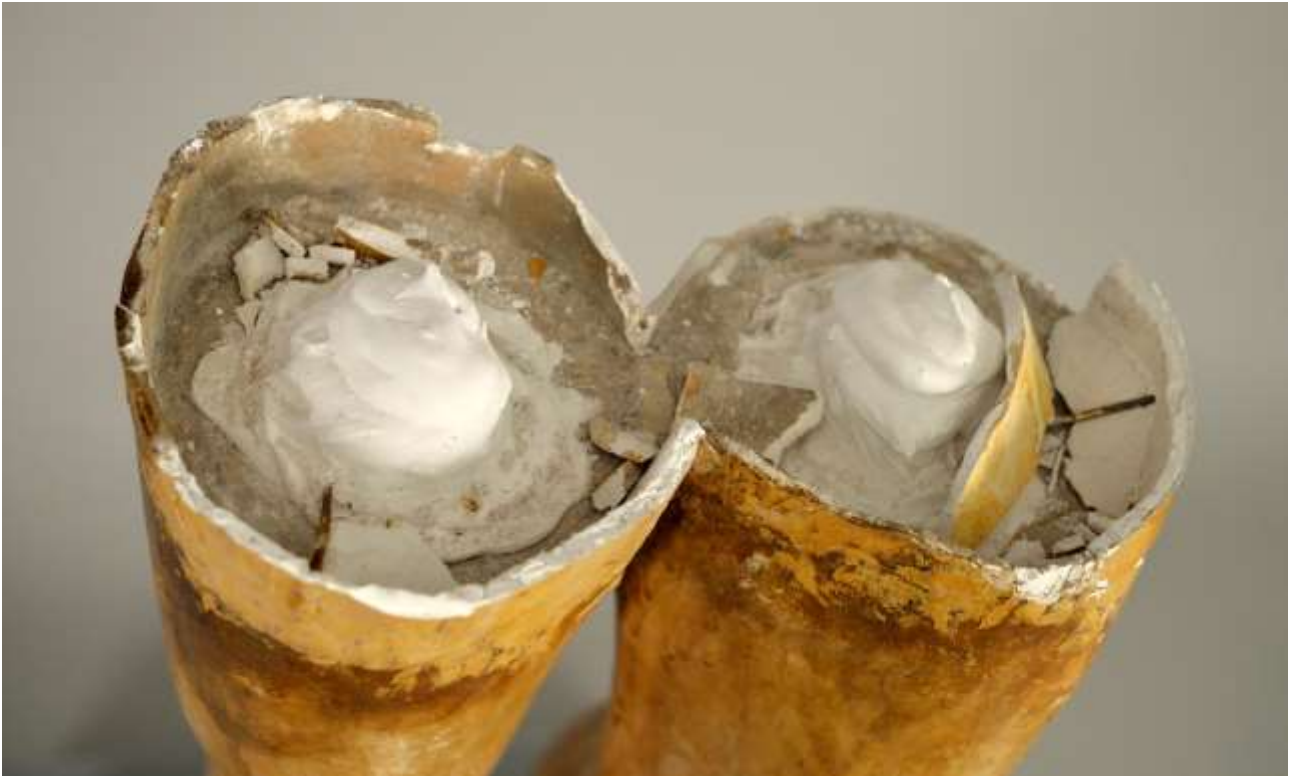
The most important degradation was located in the area that separates the body and legs. The box profile for assembling the upper part of the body to the legs was very much damaged, because this area of the sculpture has suffered from permanent use. In this area, the plaster had become extremely weak and several areas were lost. (*Photo 39.*)

*Photo 39.* Box profile before restoration.

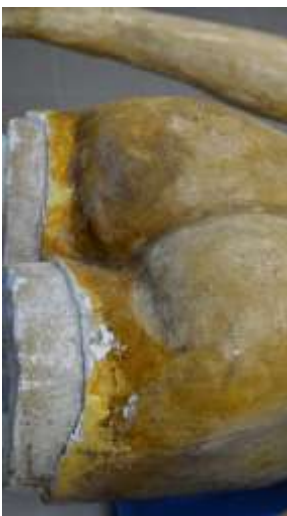
*Photo 40.* Previous repairs on the union areas between the legs and body

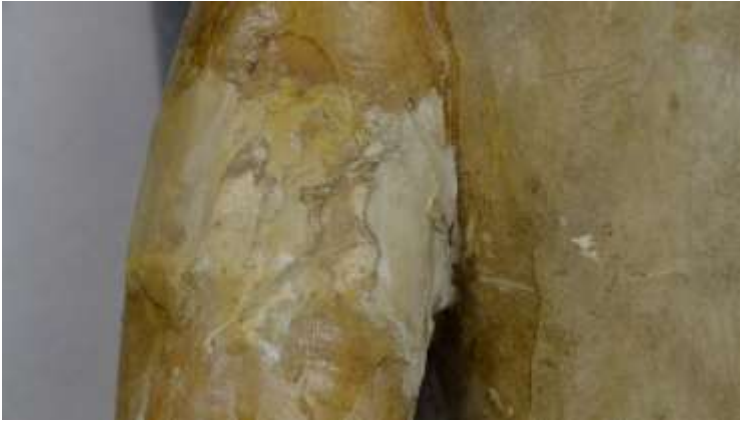
*Photo 41.* Previous repairs on the union area between the arm and shoulder.

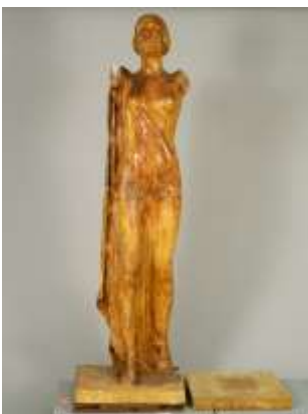
*Photo 50.* Initial conservation condition before restoration.

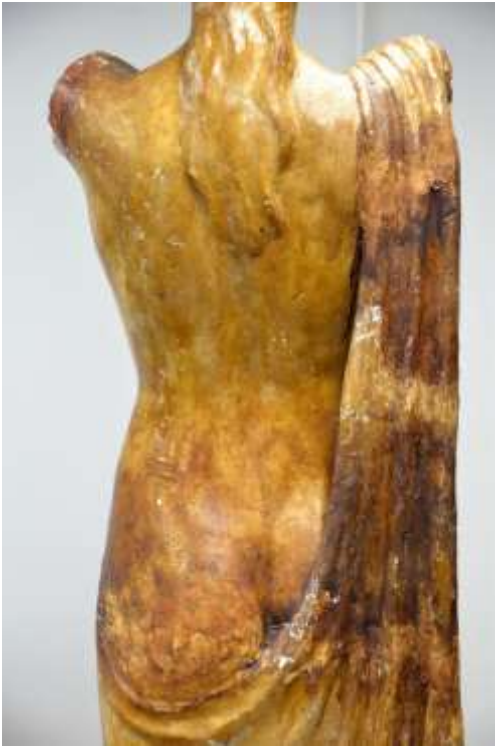
*Photo 51.* Previous restorations on the back side of the sculpture.

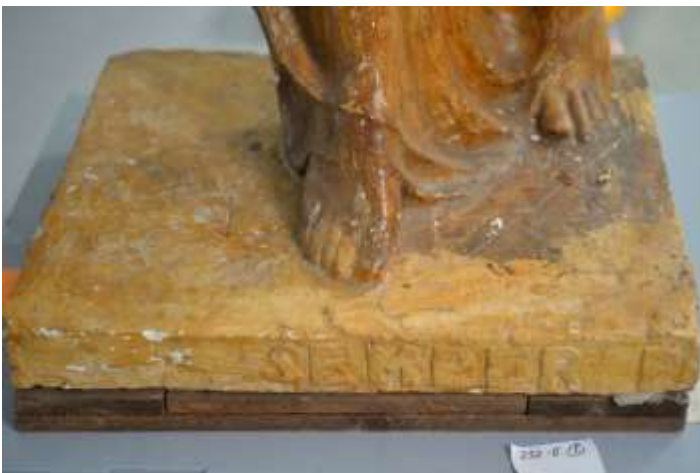
*Photo 52.* Previous restoration on the base of the sculpture with reproduction of the letters.

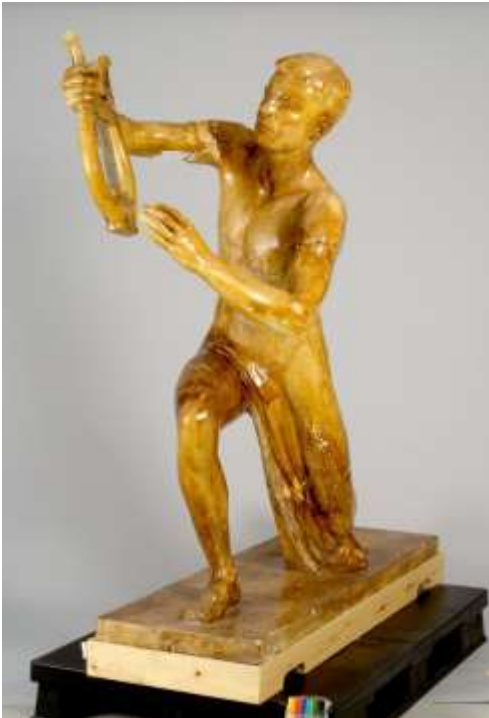
*Photo 64.* Initial conservation condition before restoration. Extended dark brown areas hiding plaster alterations.

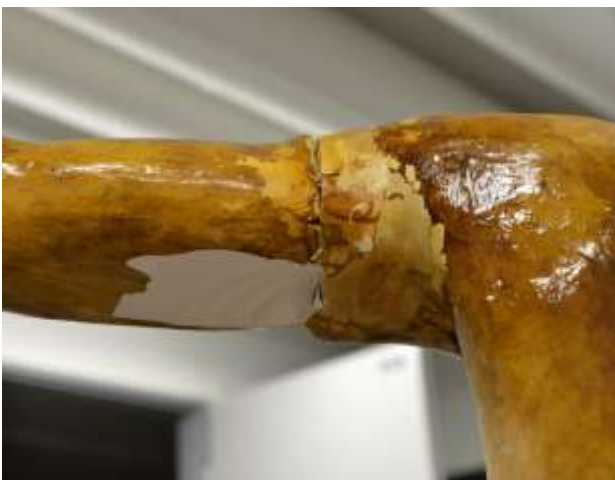
*Photo 65.* Union area between the right arm and shoulder before restoration shows previous repairs intended to solve joining issues.

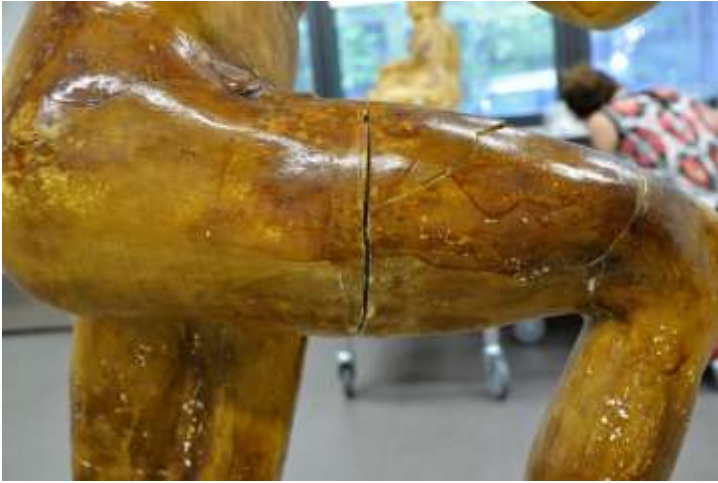
*Photo 66.* Right leg before restoration shows severe structural problems.

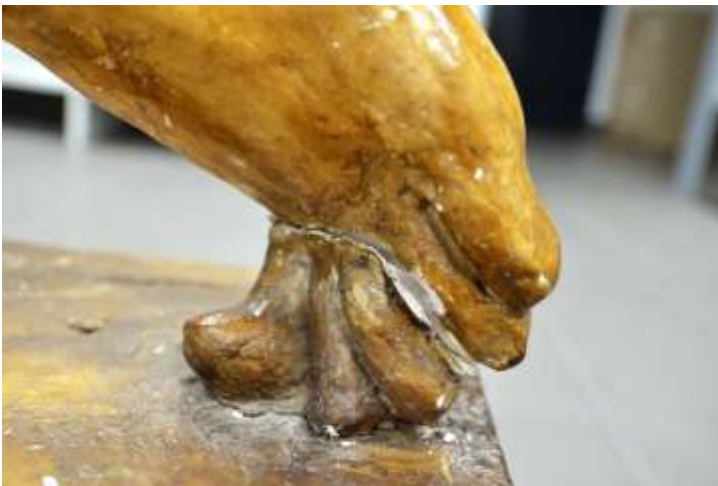
*Photo 67.* Back foot before restoration shows fractures and separation from the base.

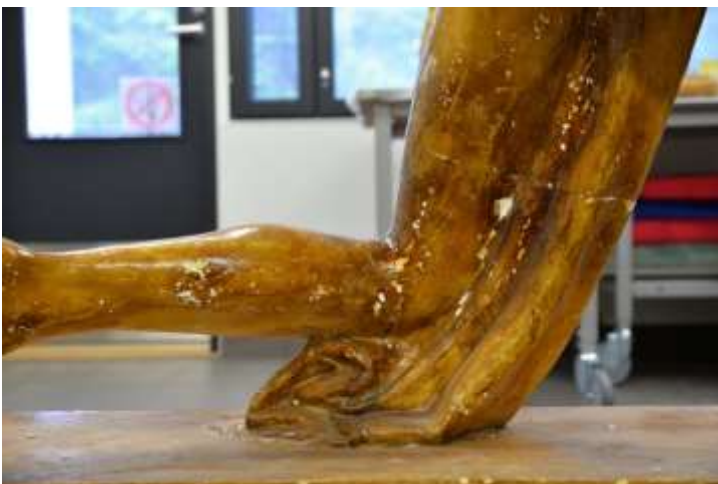
*Photo 68.* Lower areas of the figure before restoration. Many cracks and fractures have raised and caused detachment of the colour coating.

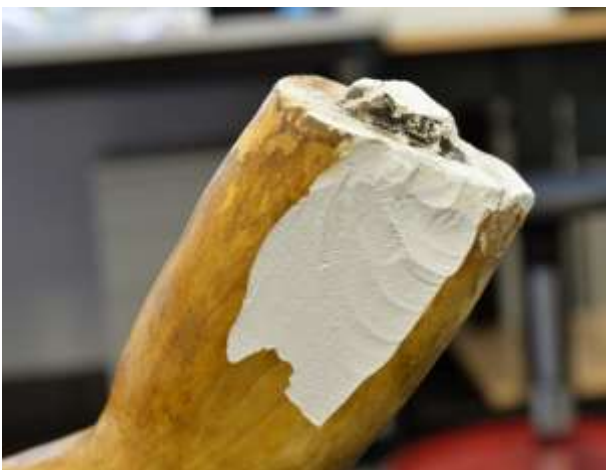
*Photo 70.* Right arm, broken anchorage system.

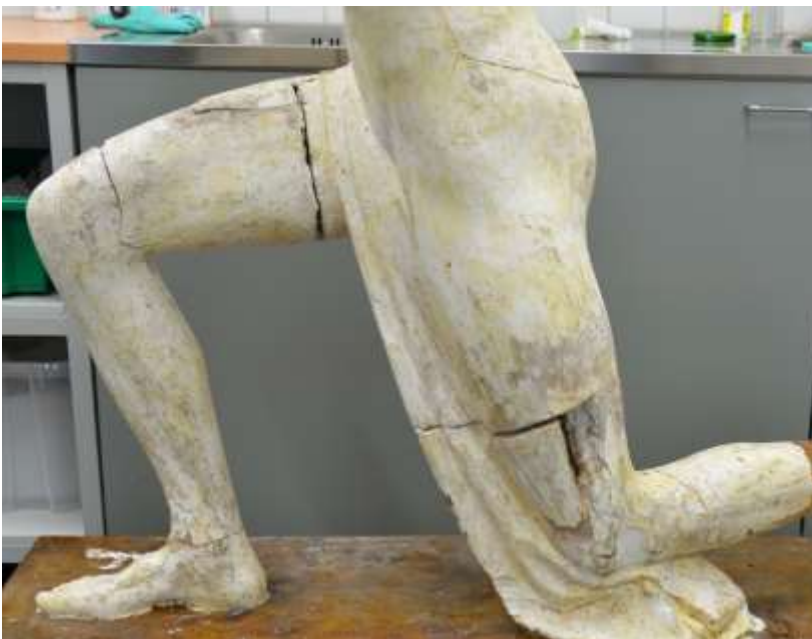
*Photo 72.* Severe alterations are shown on both legs after removing varnish coatings.

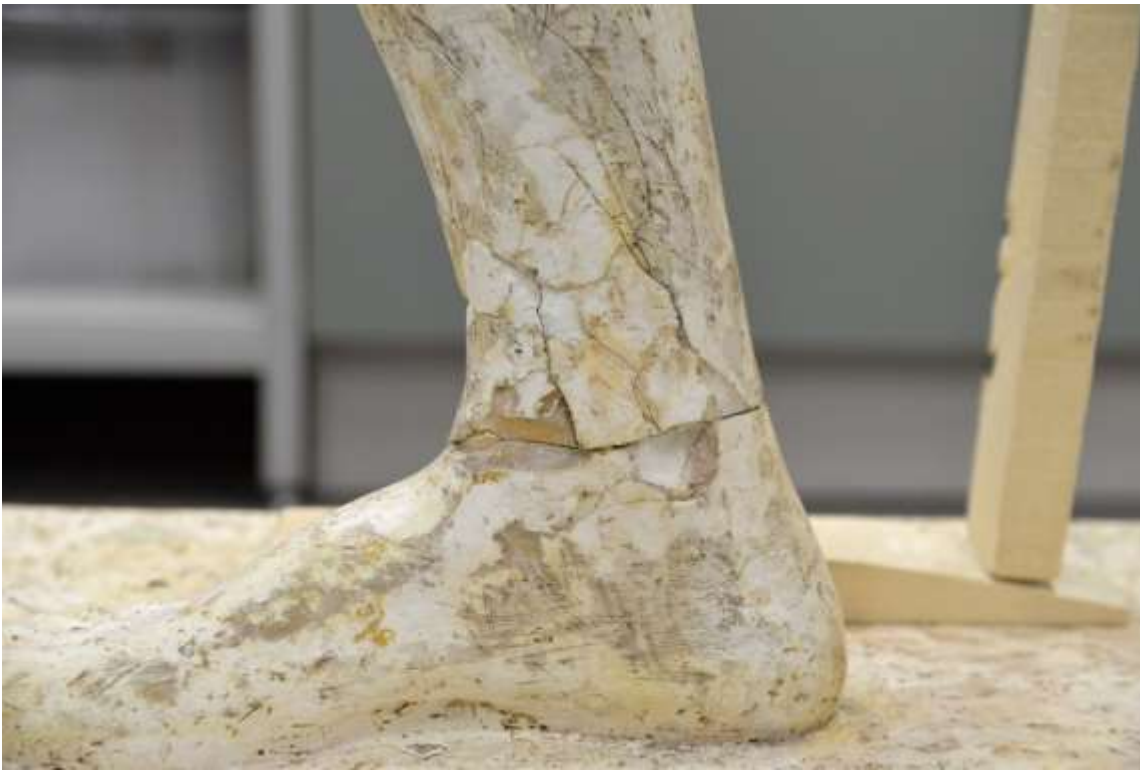
*Photo 73.* Fragmentation on right foot after removing varnish coatings.
