SAVING EEMIL - CONSERVATION PROJECT 2017–2018  
Final report 31.8.2018

The Halonen Museum Foundation – The Art Museum Eemil, Lapinlahti 2018

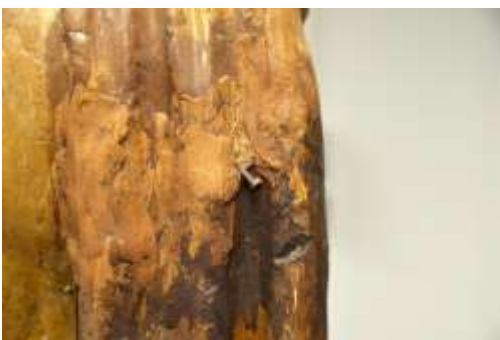
The most repaired parts of the sculptures tend to be the most delicate, which over time have been fractured, for example arms, ankles or bases of the sculptures. These old reparations significantly alter and modify the original visual concept. In the sculptures with superposition of these old reparations, the added materials have covered the original surface with plasters, shellac or varnish colours. (*Photos 13, 14, 15.*)

*Photo 14. Old unsuitable adhesive treatments with glue, iron nails and plaster on the back side of Semper Excelsior Sculpture.*

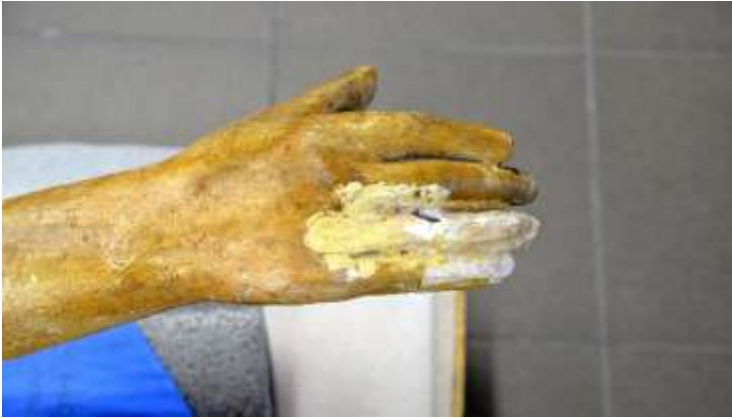
Photo 15. Old unsuitable reconstruction of the lost fingers on *Vapaus* sculpture.

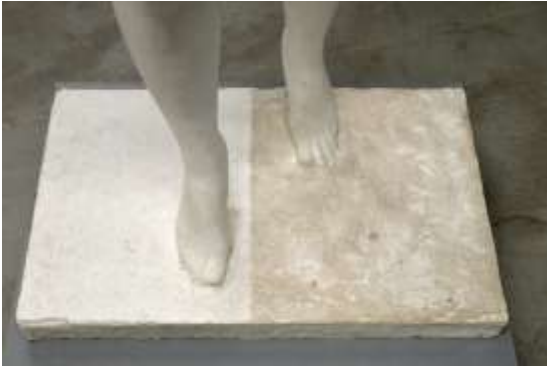
Photo 17. Cleaning treatment on process with Agar-Agar and eraser on *Kirkkauteen* sculpture.

When plaster sculptures have dirt adhering, cleanings based on soft erasers or Wisab cleaning foams are applied. The complete elimination of stains on white plaster has required the use of aqueous systems in gel. Agar-Agar gel has been selected for the good results obtained and the consensus among specialists on its use for cleaning plaster.<sup>4</sup> (*Photos 17, 18*) Agar-Agar has a great capacity of water retention, which allows long contact times with a limited absorption from the material, which is a desirable circumstance, especially where porous, hygroscopic, soluble or materials sensitive to the action of water, such as plaster. The main advantages of this gel are as follows: not harmful to the plaster superficial layer; very effective absorption of stains and dirt deposits; and finally, that the remaining residues are easily removed with a soft brushing.

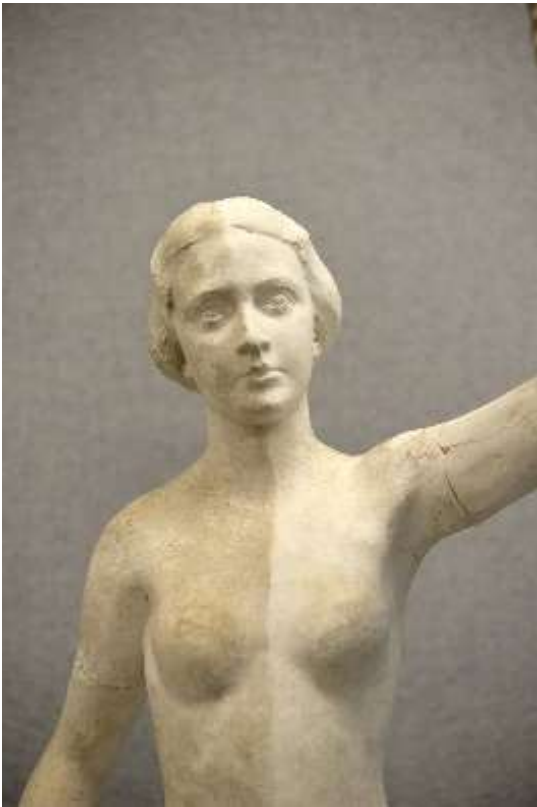
Photo 18. Cleaning treatment on process with eraser tools on *Värttinätyttö* sculpture.

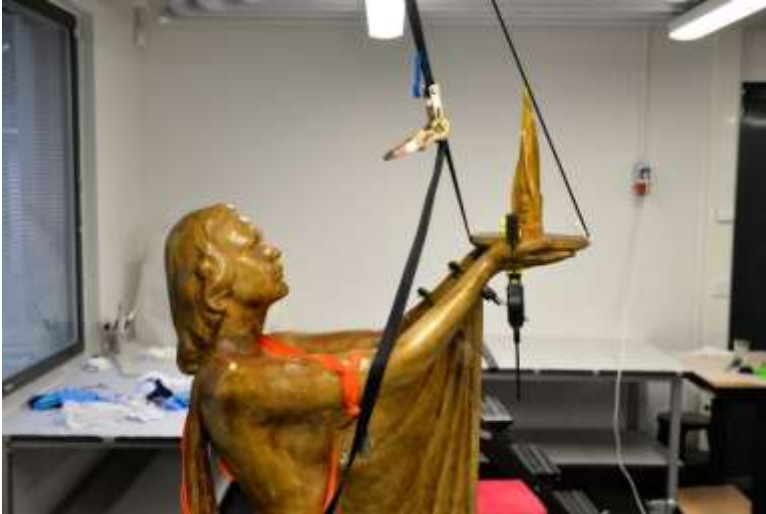
Photo 27. Adhesion of fragments on the arms of *Uhri* sculpture.

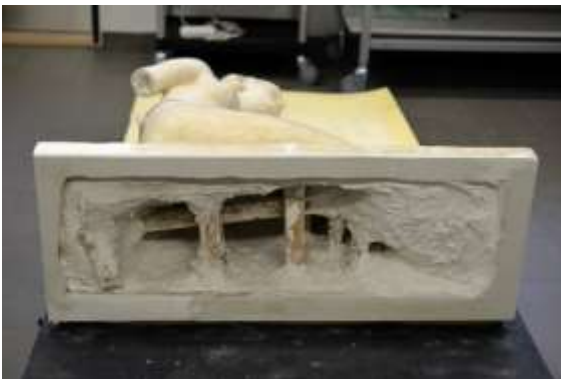
Photo 31. *Elämänlankavyty* sculpture base after restoration treatments.

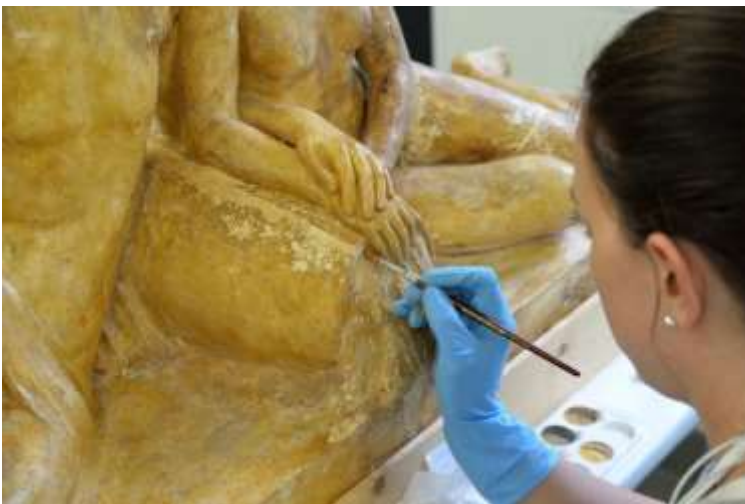
Photo 36. Colour retouching on lost chromatic areas on *Autuaitten Asunnolla*.

Gouache and acrylic colours have been used with removable techniques to facilitate the possibility of removing these colours in the future. (Photos 35, 36.) The areas where colour retouching has been made are as follows:

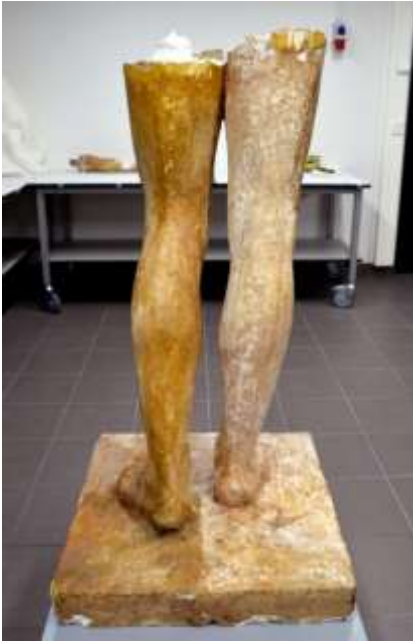
*Photo 43.* Cleaning process on the legs to remove old varnish and overpaint from previous restoration.

Mechanical and chemical cleaning treatments were carried out on the surface of the sculpture, removing wax and dirt residue and previous overpaints. (*Photos 42, 43.*)

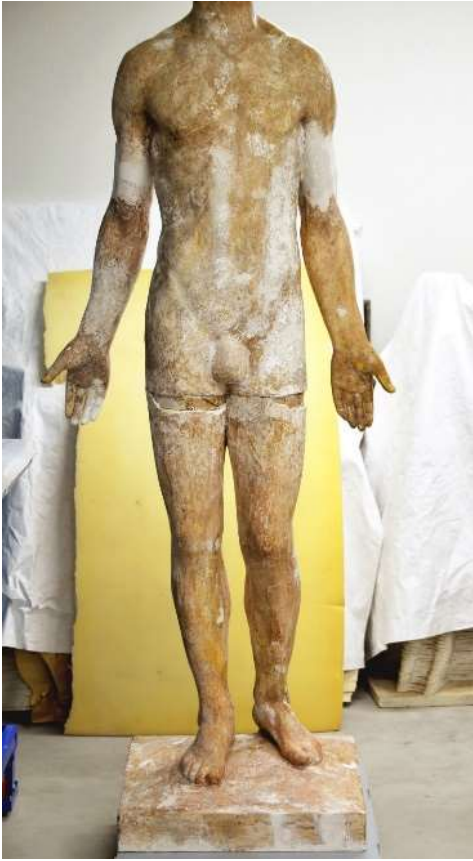
*Photo 45.* Ensemble between all the parts of the sculpture: body, legs and both arms.

Consolidation treatments were made to stabilise and give structural strength to the sculpture, consolidating the weakened plaster areas and reconstructing the box profile to match and fix the lower and upper parts of the figure. A new secure but reversible anchoring system was applied. The consolidation of the union areas for the assembly of the arms was also carried out restoring the original anchoring materials. (*Photos 44, 45, 46.*)

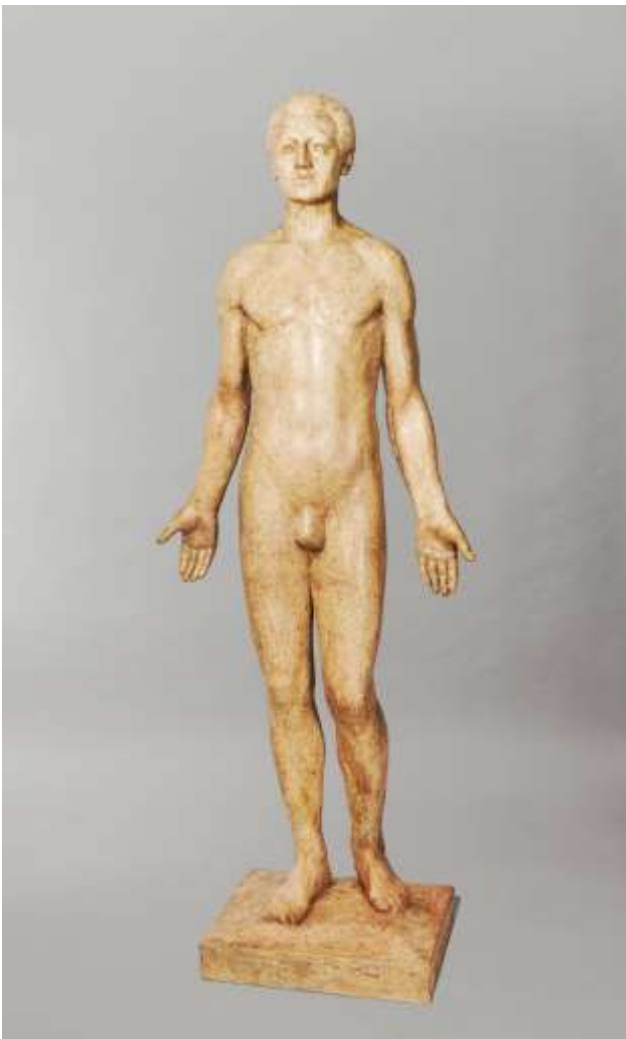
*Photo 48. Vapaus sculpture after restoration work. Photo: Titus Verhe.*

The previous plaster reconstructions were adapted, and missing plaster areas were reconstructed with new plaster. Finally, the chromatic reintegration of areas with colour loss was carried out using reversible materials and techniques, to return the sculpture to its assumed original condition. (*Photos 47, 48*).

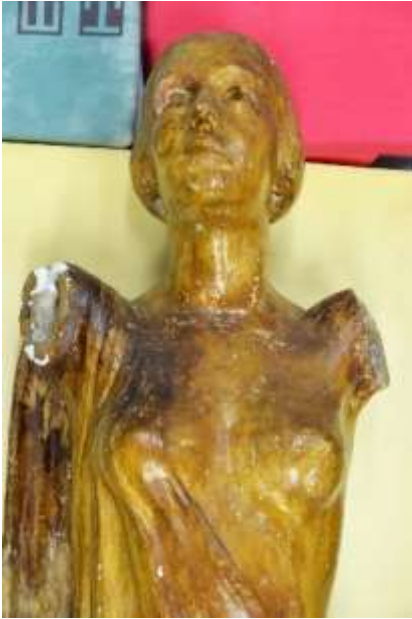
There were many chromatic alterations related to the accumulation of overpaint, glue and varnish, frequently applied one after the other for years. Mixtures of these materials, together with the dirt residue, modified the visual appearance of the figure and interfered with the understanding of original shapes and details. (*Photo 53.*)

*Photo 53. Dark chromatic alterations on the chest.*

Those materials used in previous arrangements were not adequate. As they aged, they had darkened and weakened, so it was necessary to remove them.

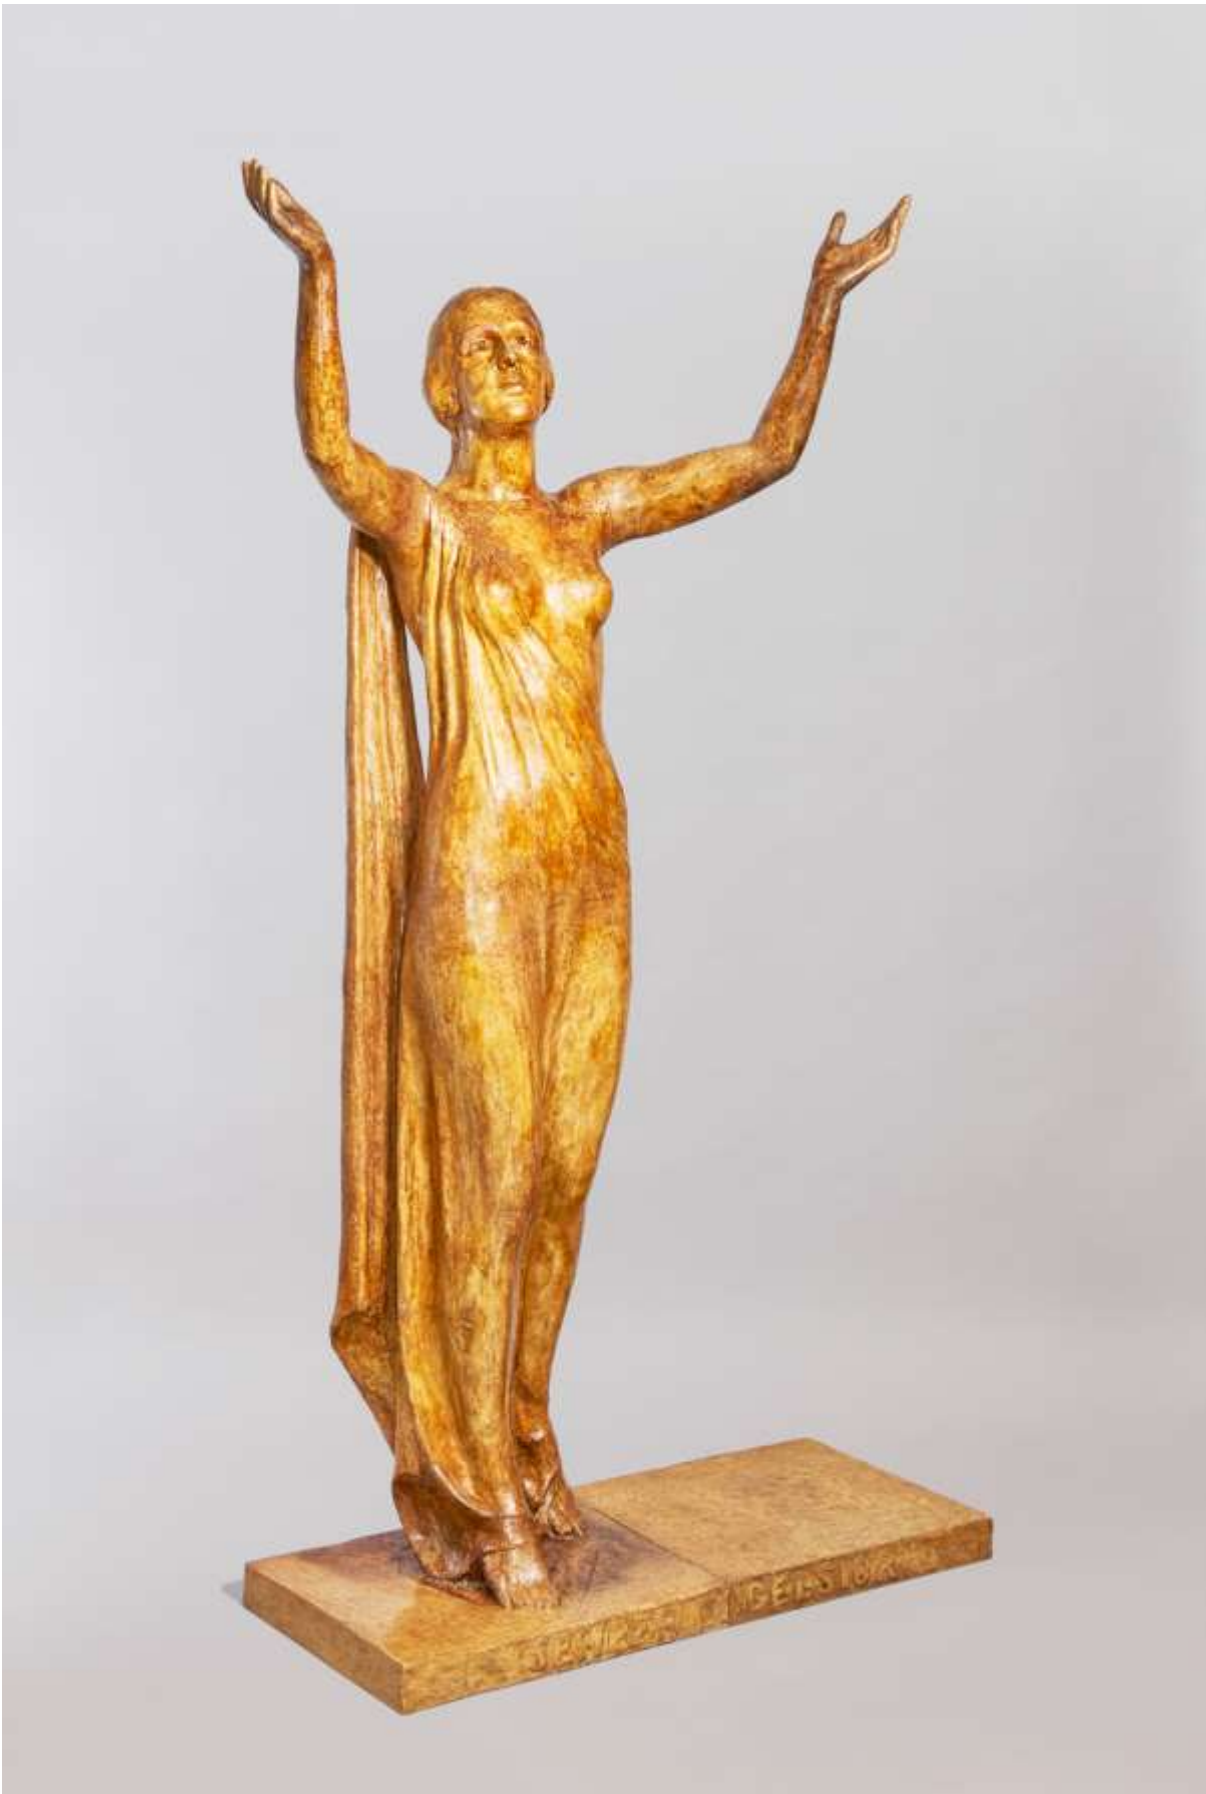
*Photo 61. Semper Excelsior sculpture after restoration work. Photo: Titus Verhe.*

The arms have been reattached to the body using an anchoring system that allows the possibility to disassemble in the future. The union areas between the arms and body have been reinforced and filled with plaster.

Finally, the figure was chromatically reintegrated with retouching gouache colours according to the chromatic tones provided by the original colour coating. (*Photo 61.*)

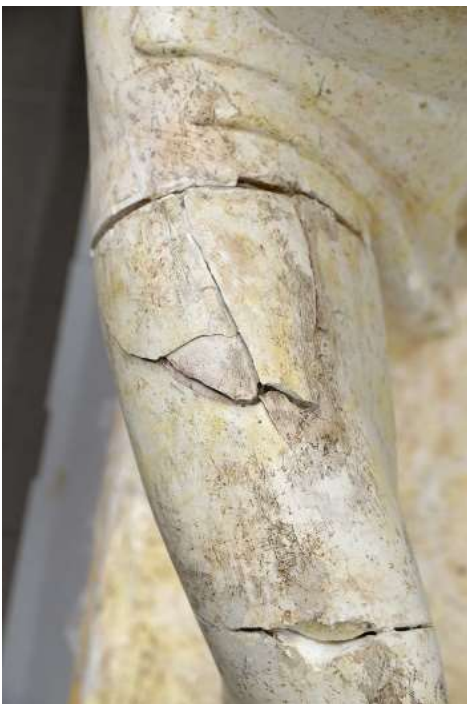
*Photo 78. Restoration process on the right leg.*

Colour retouching was done with gouache pigments to chromatically reintegrate the figure according to the chromatic tones provided by the remaining colours from the original coating. A transparent thin coating of shellac was applied as an intermediate film before the colour retouching to enable reversibility of surface coatings. (*Photos 78, 79, 80.*) Finally, a layer of transparent protective varnish of dammar resin was applied. (*Photo 81.*)

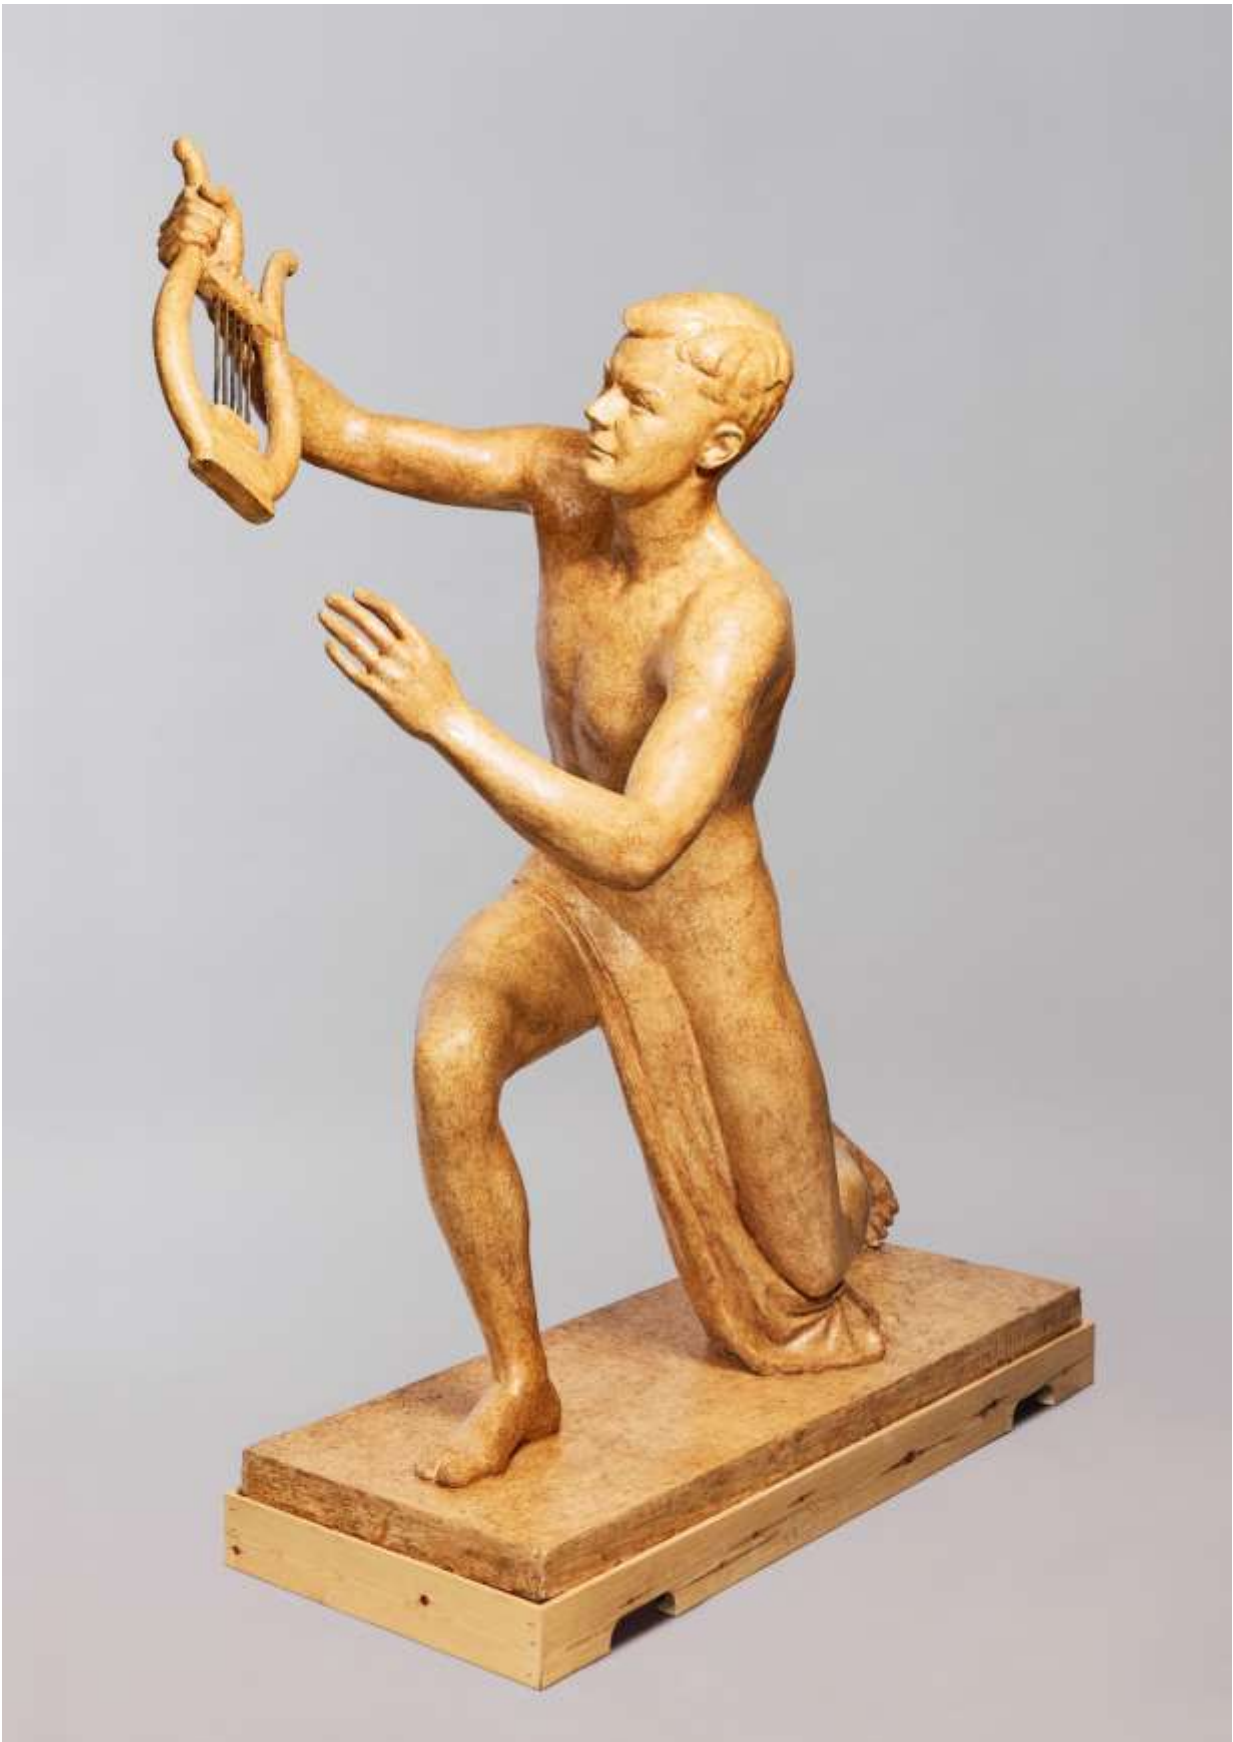
*Photo 81.* Lyyran soittaja sculpture after restoration work. Photo: Titus Verhe.
